CAPSTONE DESIGN & RESEARCH PROJECT III SEMELI HOTEL

NICOSIA, JULY 2025

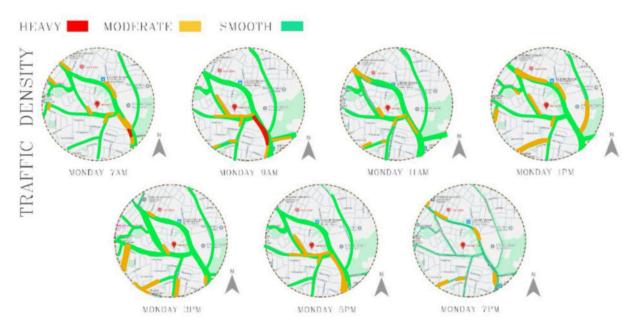
Diagram 2.2. Traffic Density

- ➤ 07:00 a.m. The traffic is generally smooth (green), with some moderate (yellow) spots on the main roads. Overall, traffic flow is relatively smooth.
- ➤ 09:00 a.m. A significant increase in traffic, with clear signs of congestion (red). This is the peak time for commuting to work or school.
- ➤ 11:00 a.m. Traffic decreases, with smoother flow (green) and moderate traffic (yellow) observed.
- ➤ 13:00 p.m. Traffic is mainly smooth (green), with some moderate (yellow) spots.
- ➤ 15:00 p.m. Traffic remains smooth (green) and moderate (yellow).
- ➤ 17:00 p.m. Traffic is smooth (green) with some moderate (yellow) spots. Moderate traffic is observed on the roads in front of the hotel.
- ➤ 19:00 p.m. Traffic is mainly smooth (green), with some moderate (yellow) spots on the main roads. Traffic flow is relatively smooth.

In summary, moderate traffic is observed on the nearby roads of the hotel, particularly during the hours of 09:00 a.m., 01:00 p.m., and 05:00 p.m. The hour of 09:00 a.m. stands out for the highest traffic density at the traffic lights due to people commuting to their workplaces. Additionally, during these specific hours, increased noise levels are observed in the area.

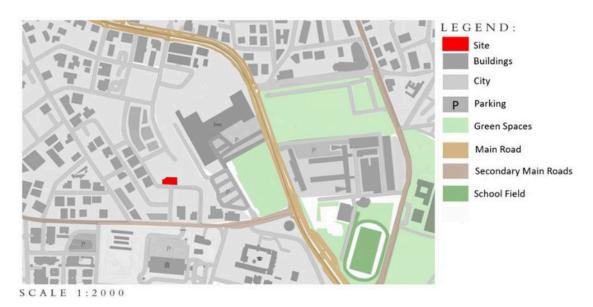
Image 2.4. Masterplan

The scale of the plan (1:2000) offers precise information about distances and the arrangement of elements. It can be observed that the hotel is located in close proximity to the main road, which is depicted in dark yellow (Main Road), facilitating access for both vehicles and pedestrians. Additionally, the proximity of green spaces and school facilities (School Field) enhances the character of the area as a vibrant and multifaceted environment.

The presence of multiple parking areas (Parking) indicates that the area is well-served in terms of infrastructure. However, the fact that the hotel itself does not have private parking space for its staff and guests affects its functionality. In conclusion, the strategic location of the Semeli Hotel combines easy access and connectivity with a diverse urban environment, making it ideal for both leisure and business activities.

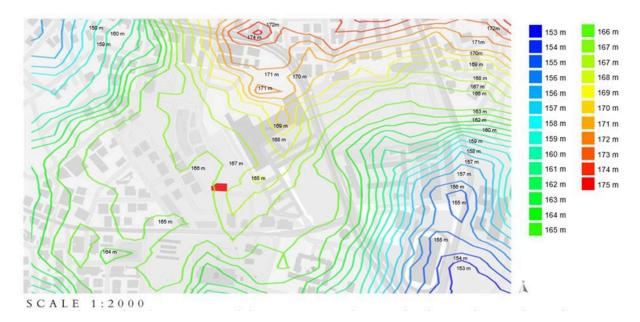
Image 2.5. Contour Lines

The contour lines indicate that the hotel is located at an elevation of 166-167 meters above sea level. The flat topography facilitates construction and reduces infrastructure costs. The map's detail, with a scale of 1:2000, provides important information regarding the elevation differences.

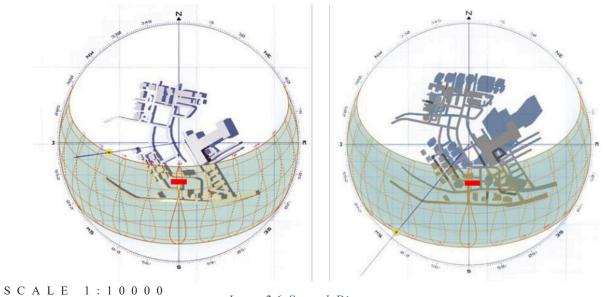
Image 2.6. Sunpath Diagrams

The solar diagram shows that the design of the hotel must be flexible to adapt to seasonal variations in light and temperature. This information helps in creating energy-efficient and environmentally sustainable designs.

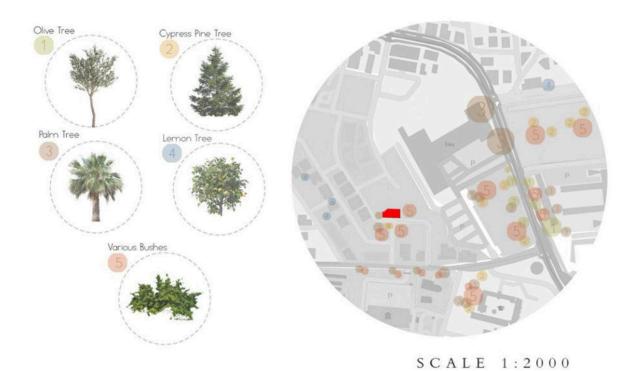
Diagram 2.7. Vegetation Diagram

The following diagram shows the vegetation in the area. Observations indicate that there are many shrubs and Cypriot trees, such as olives, cypresses, palm trees, and lemon trees. Most of the trees are located near schools and residential areas. It is important to integrate this vegetation into the design of the area to maintain ecological balance.

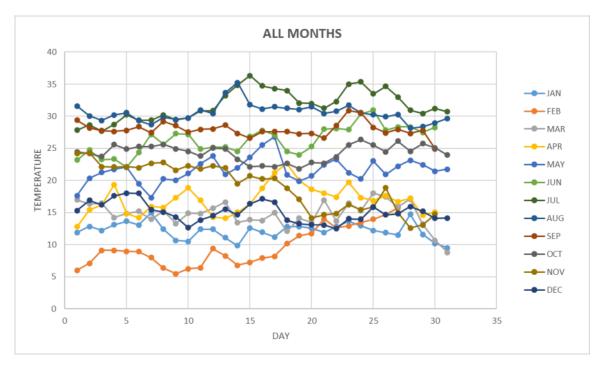
Graph 3.1. Monthly Temperature

Some months, such as August and January, show lower values of variation compared to the others. January, February, and November appear to have similar fluctuations, but with lower values compared to July or September. Months like June and July display high values.

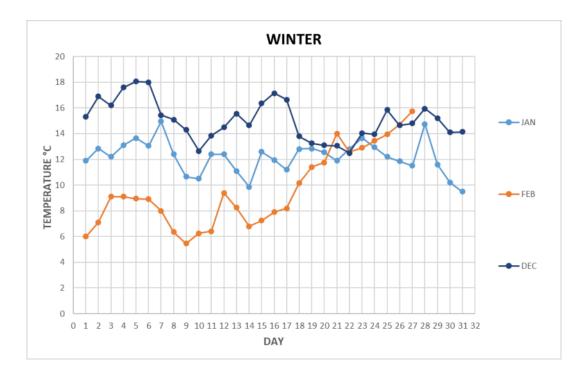
Graph 3.2. Temperature in Winter

During the winter months, it appears that December starts with higher temperatures and decreases towards the end of the month. January seems to have the most stable temperature, while February experiences the most variation, starting at around 6 degrees and ending with approximately 16 degrees.

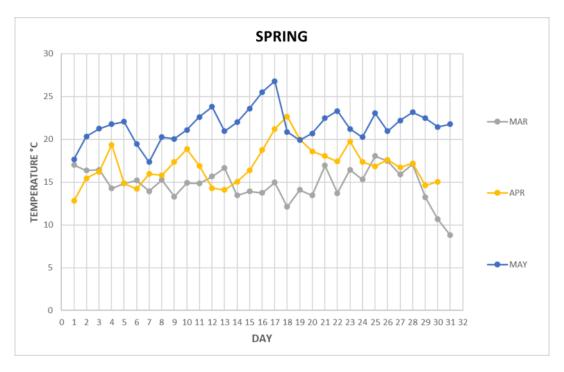
Graph 3.3. Temperature in Spring

Spring seems to start with lower temperatures, as it follows winter in the month of March. However, the temperature during this month is almost stable, except for the last four days. April shows an upward trend compared to March, while May experiences a larger increase compared to the previous months.

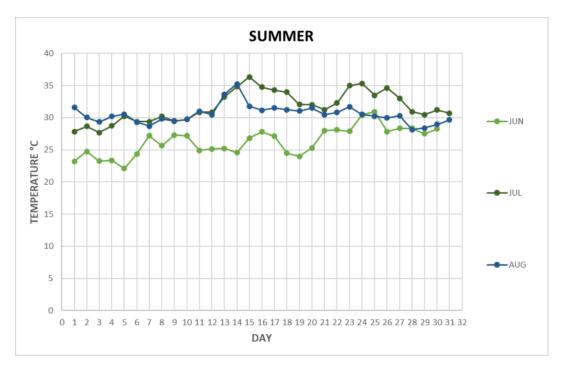
Graph 3.4. Temperature in Summer

The summer months show the greatest increase in temperature. July and August have the highest temperatures of all months in the year, which is expected as they represent the peak of summer. June also experiences high temperatures, but they are somewhat milder compared to the other two summer months.

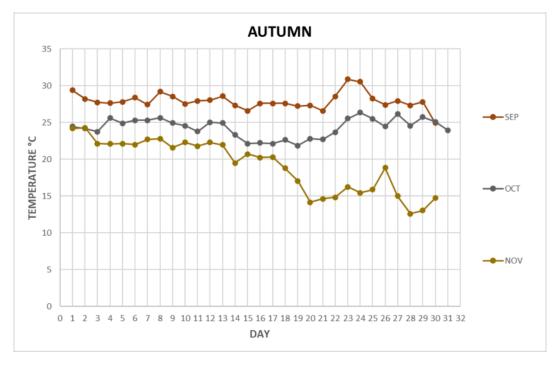
Graph 3.5. Temperature in Autumn

During the autumn months, we observe greater fluctuations between the months, as September follows summer, while November precedes winter. September has relatively high temperatures, which decrease towards the end of the month. This is followed by October, which shows almost stable temperatures that reflect the drop from September. November starts with temperatures similar to October's, and after mid-month, a gradual decrease begins, leading to temperatures 10 degrees lower than at the start of the month.

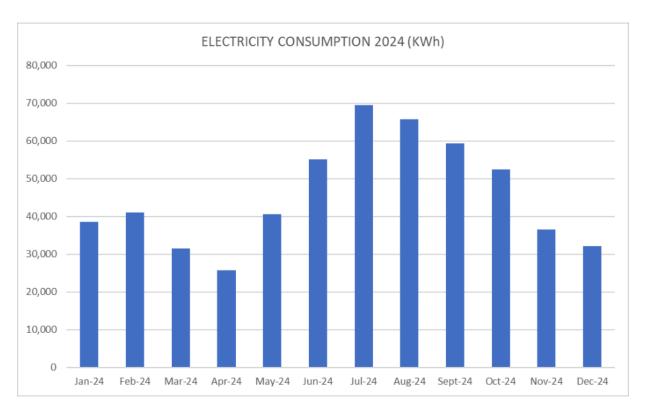
Grafic 4.2a. Analysis of EAC Bills

According to the above table and diagram 4.2a, it is observed that during the summer months, electricity consumption increases due to the higher use of air conditioning systems. The total electricity consumption of the hotel for the year 2024 amounted to 548,368 kWh, with a total cost of &148,697, excluding VAT. The cost per kWh, which will be used as a basis for subsequent techno-economic analyses, amounts to &0.271/kWh.

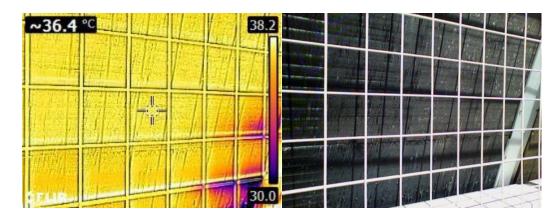
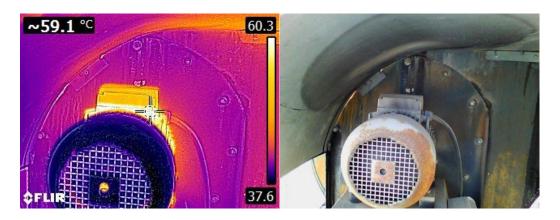
Regarding the thermography of the mechanical equipment and HVAC, it is observed that according to the SuccessIRiesTM 104 standard: Temperature Limits for Electrical & Mechanical Equipment [3], the temperatures for all cases are within the permissible limits, as they are below 70°C.

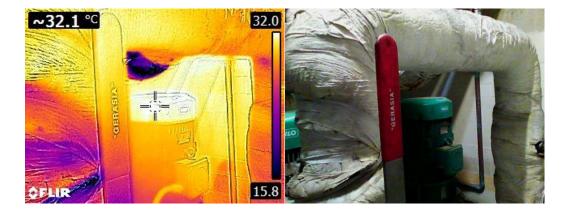
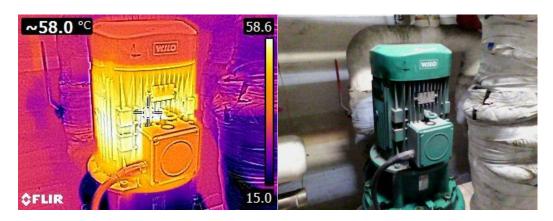
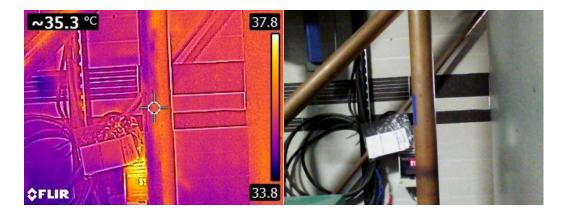
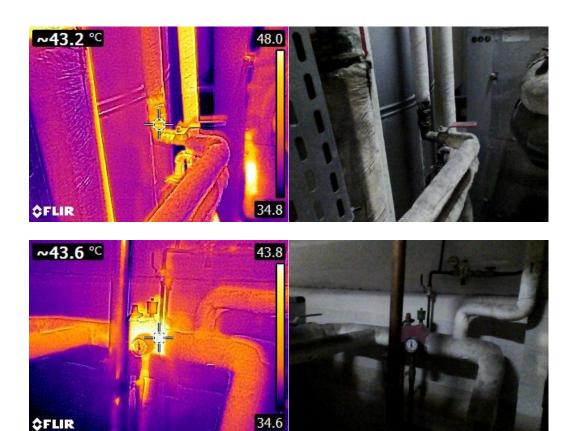
Regarding the thermography of the Boiler Pumps & Piping, it is observed that according to the SuccessIRiesTM 104 standard: Temperature Limits for Electrical & Mechanical Equipment [3], the temperatures for all cases are within the permissible limits, as they are below 70°C.

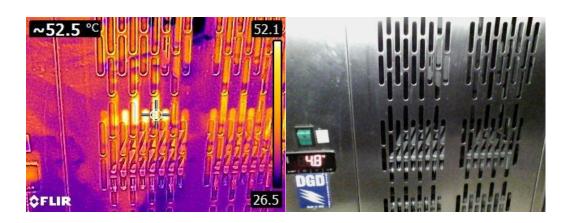
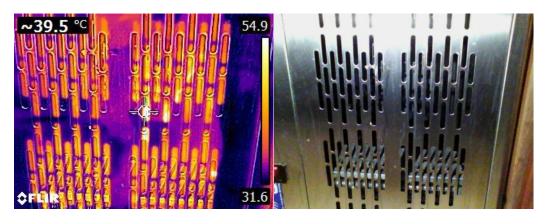
Regarding the thermography of the Refrigeration Equipment, it is observed that according to the SuccessIRiesTM 104 standard: Temperature Limits for Electrical & Mechanical Equipment [3], the temperatures for all cases are within the permissible limits, as they are below 70°C.

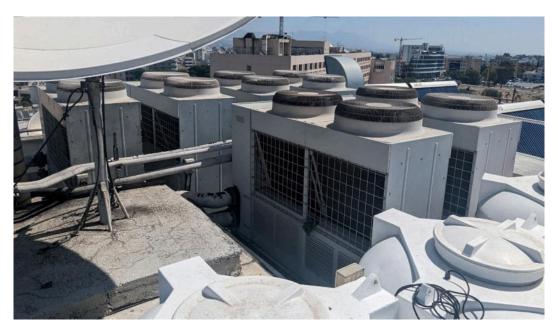
Image 4.4.1a. Six Chillers on the Roof of the Building

The air conditioning system of the hotel (heating and cooling) is provided by 6 chillers, in combination with 16 cassette units, 9 standalone air conditioning units, and 86 built-in cassette units in the common areas of the hotel, such as rooms, kitchens, etc.

The model of these chillers is MGA-F65W/SN, with a heating performance factor (COP) of 3.009 and a cooling performance factor (EER) of 3.286. However, these units are considered quite energy-intensive, as they are relatively old and therefore cannot operate at their maximum efficiency, with empirical data suggesting a potential performance loss of up to 40% (EER = 1.81 and COP = 1.98). It is worth noting that they consume more energy compared to modern units, as indicated by the fact that their heating and cooling performance factors fall below 3.00, whereas modern chillers have significantly higher performance ratings.

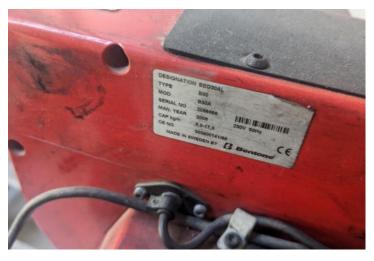
Image 4.4.2b. Techical Specification of Burner

At Semeli Hotel, heating is also provided with the help of two oil boilers, in addition to the chillers. Notably, the use of the two boilers also produces Domestic Hot Water (DHW). The building has two oil boilers and two BEO30AL burner units, which have an electrical power ranging from 71 to 202 kW.

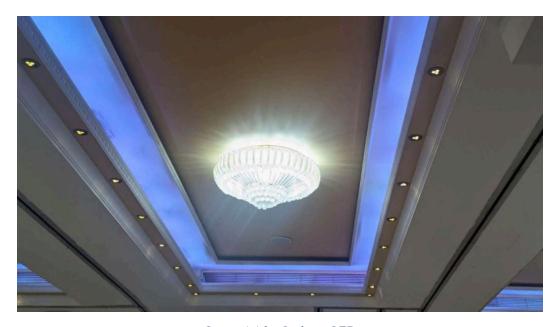
Image 4.4.3a. Lighting LED

The lighting installed in the hotel consists of LED bulbs, which consume less electrical energy as they are more energy-efficient compared to conventional bulbs. It is also worth noting that LED bulbs have a longer lifespan compared to conventional bulbs.

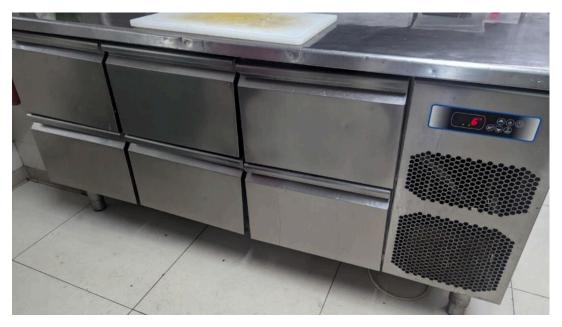
Image 4.4.4a. Refrigeration Equipment

The storage of products for food preparation and processing in the kitchen, as well as the storage of beverages in the hotel's bar, is done using refrigerators that are relatively old. As a result, there is a high consumption of electrical energy, as these systems are quite energy-intensive.

Additionally, in the kitchen, there are installed cold rooms for storing products that require freezing for preservation. It is worth noting that this equipment is also considered quite energy-consuming, as it is also quite old.

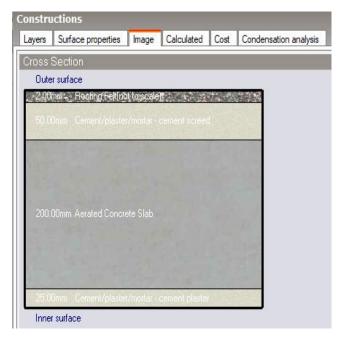
Image 5.6.6a: Roof construction

o Thickness: 0.025 m

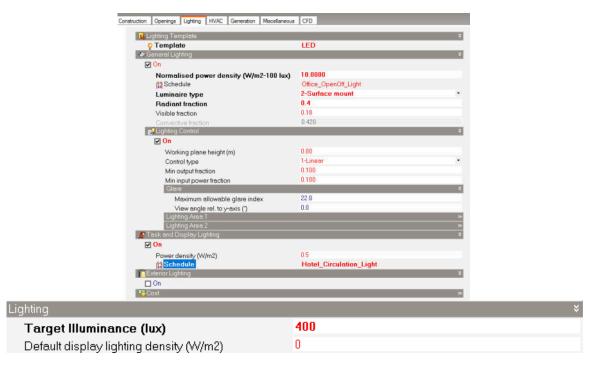
Image 5.6.8a: Lighting Template

Task and display lighting are enabled (on). The Power Density is set to 0.5 W/m², as LEDs are more energy-efficient. In the activity settings, the target illumination is defined as 400 lux.

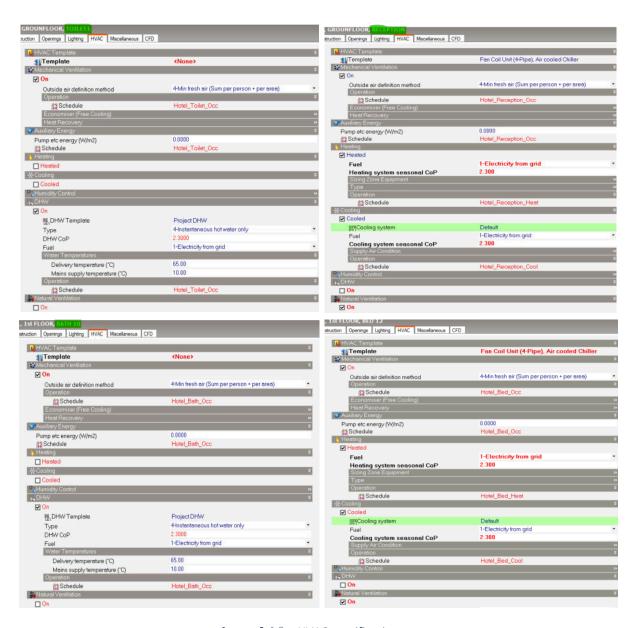
Image 5.6.8a: HVAC specification

For domestic hot water (DHW), a centralized system was defined to serve the entire building.

Additionally, in all rooms with windows, natural ventilation was implemented.

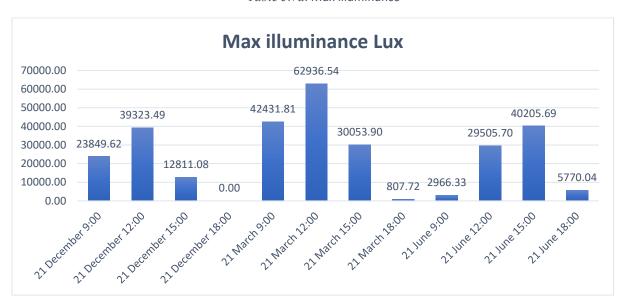
Graph 5.7a: Comparison of Maximum Illuminance Values by Month

The unit of measurement used was lux, which is the standard unit of illuminance in the International System of Units (SI). For the evaluation of the results, we set acceptable limits for natural lighting intensity between 300 and 3000 lux, in accordance with established specifications for comfort and sufficient lighting conditions in indoor spaces.

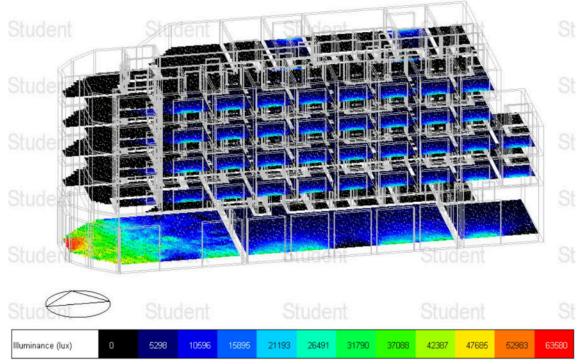
Table 5.7a: Natural Lighting Simulation

As shown in the Image 5.7a, the ground floor receives the highest amount of natural light. This phenomenon is attributed to the presence of large glazed surfaces and openings on the façades of the ground floor, which allow sunlight to enter the interior. As a result, the indoor spaces on the ground floor benefit more from natural lighting, a fact reflected in the higher values observed on the illuminance scale.

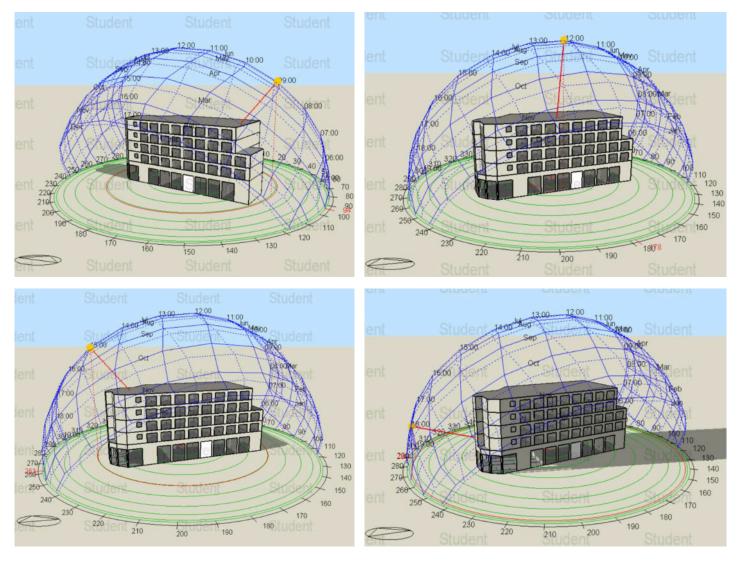
Image 5.8a: Sun Path Diagram

In the Image 5.8a, the sun path diagram is shown, illustrating the position of the sun in the sky throughout the day. More specifically, the angular positions of the sun at 09:00, 12:00, 15:00, and 18:00 are depicted, allowing us to analyze the effects of solar radiation and shading on the building. Through the three-dimensional representation, the shadows cast by the building's envelope and architectural elements are clearly visible, directly affecting the distribution of natural light within the interior spaces.

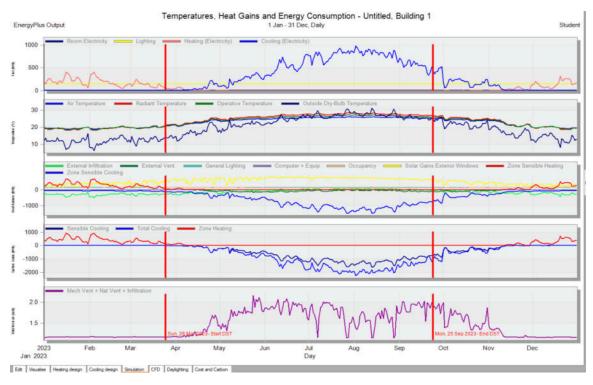
Diagram 5.9a: Diagram Annual analysis of temperatures, thermal loads, and ventilation of the entire building

Below is the diagram showing the temperatures, heating/cooling loads, and ventilation for the entire building throughout the year.

- External air infiltration
- Outdoor ventilation
- Solar gains through windows
- Heating and cooling loads per zone
- Third Graph: Cooling & Heating System (kWh) vs. Time

- Fourth Graph: Ventilation Total Fresh Air (air changes per hour, ac/h)
 This graph shows:
 - Mechanical ventilation
 - Natural ventilation
 - Air infiltration
 There is an increase in natural ventilation during the warmer months.

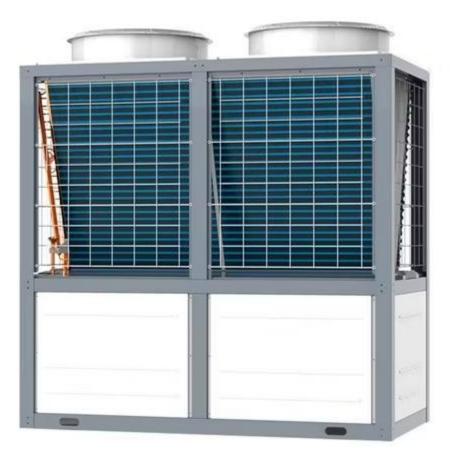
Image 7.4a. Heat Pump

- Energy Efficiency Ratio (EER) = 3.15 for cooling operation
- Coefficient of Performance (COP) = 3.15 for heating operation

This choice will contribute to a drastic reduction in the hotel's energy consumption while simultaneously improving the thermal comfort level for guests. Additionally, this upgrade will enhance the building's overall energy class and achieve significant reductions in operational costs.

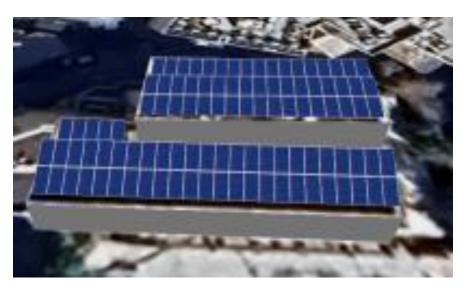
Image 7.5a. Photovoltaic System of the roof

To evaluate the proposed solution, a simulation was conducted using SolarEdge software, which shows the exact layout of the photovoltaic panels on the building's roof. The related visualization is included in the following image.

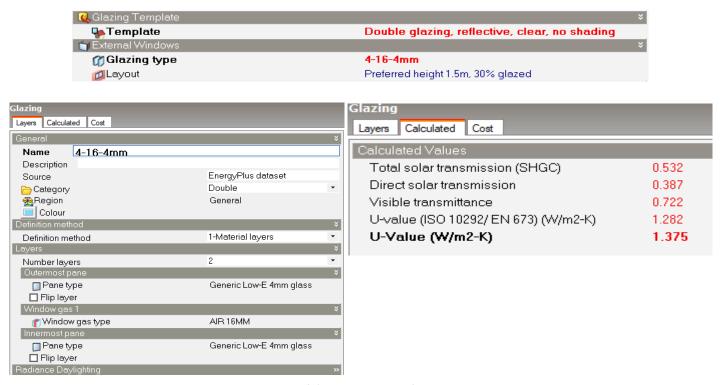
Image 8.3a: Window specifications

Replacement of the existing glazing with double-glazed units of type 4 - 16 - 4, featuring an air gap and reflective coating, but without additional protective layers. Replacement with frames featuring reduced heat losses and improved performance.

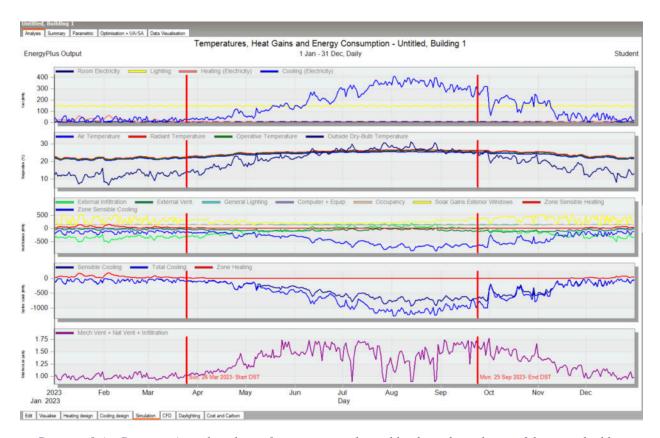
Diagram 8.4a: Diagram Annual analysis of temperatures, thermal loads, and ventilation of the entire building

Below is the diagram showing the temperatures, heating/cooling loads, and ventilation for the entire building throughout the year, after the building's upgrade.
