# ENERGY UPGRADE OF STROVOLOS MUNICIPAL BUILDING

*POL 804: ADVANCED PROJECT: INTEGRATED DESIGN AND  
PROJECT RESEARCH I I I*

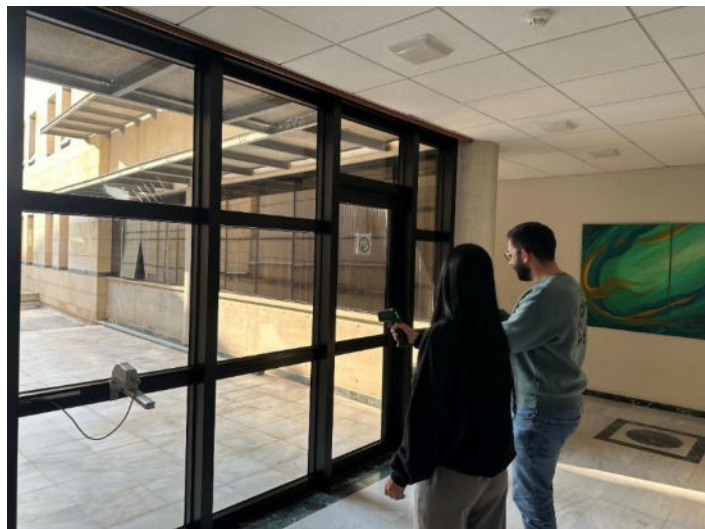
*Figure 12: Window measurements*

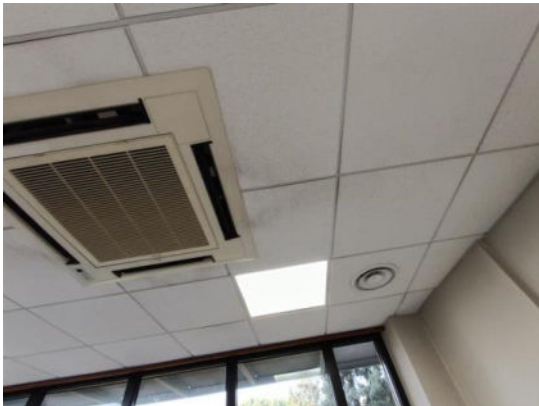
In Figure 14, in the indoor air conditioning units, a leak was observed from the condensate pipe in the suspended ceiling, resulting in the accumulation of water and wear of the suspended ceiling.

*Figure 14: Leakage from the condensate pipe in the suspended ceiling*

As part of the HVAC system upgrade, it is proposed to repair and replace the thermal insulation on the refrigerant piping of the VRV systems, both on the rooftop and within the false ceilings. Over time, the insulation on these pipes has deteriorated due to weather exposure, UV radiation, and mechanical wear, resulting in increased thermal losses and reduced system efficiency.

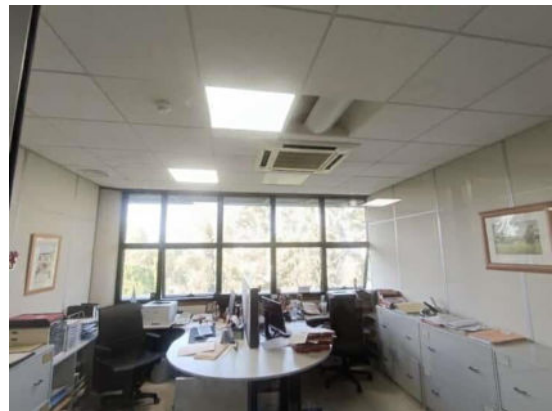
In Figure 15, insufficient thermal insulation was found in the office frames, which causes instability in the temperature of the rooms. In addition, the luminaires are not LED technology, thus leading to unnecessary energy consumption.

*Figure 15: Office frames and lighting fixtures*

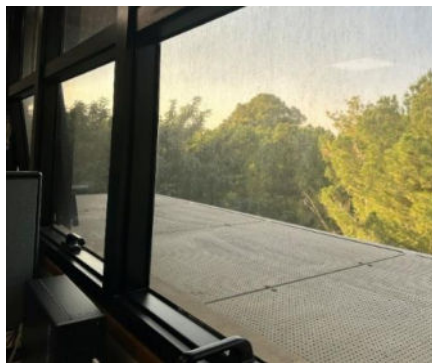
In Figure 16, difficulty was observed in cleaning the windows due to the external shades. Although their original purpose was to offer convenience, they ultimately act as a barrier, allowing dust to accumulate on window surfaces.

*Figure 16: Windows and exterior sunshades*

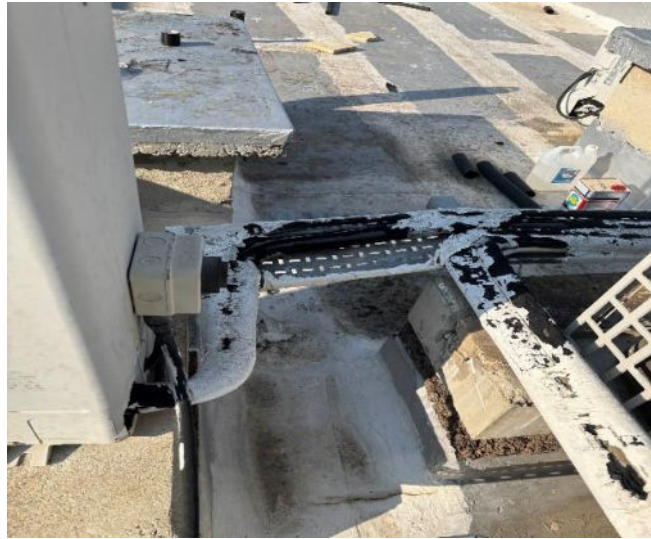
The insulation of the VRV and Chiller piping was found to be damaged, leading to substantial energy losses. This deterioration in insulation compromises the efficiency of the systems, as heat transfer is no longer adequately controlled. Furthermore, critical equipment was left exposed to extremely high temperatures, which not only reduces the performance of the machinery but also increases the risk of wear and tear over time. These problems underscore the urgent need for maintenance and protective measures to ensure both energy efficiency and the longevity of the equipment.

*Figure 17: Piping wear and damages*

Poor or damaged insulation on refrigerant pipes can lead to significant energy losses. Based on typical industry data and case studies, heat loss from uninsulated or poorly insulated refrigerant lines can result in a 5% to 15% increase in energy consumption for air conditioning systems, depending on pipe length, temperature difference with the environment, and exposure conditions.

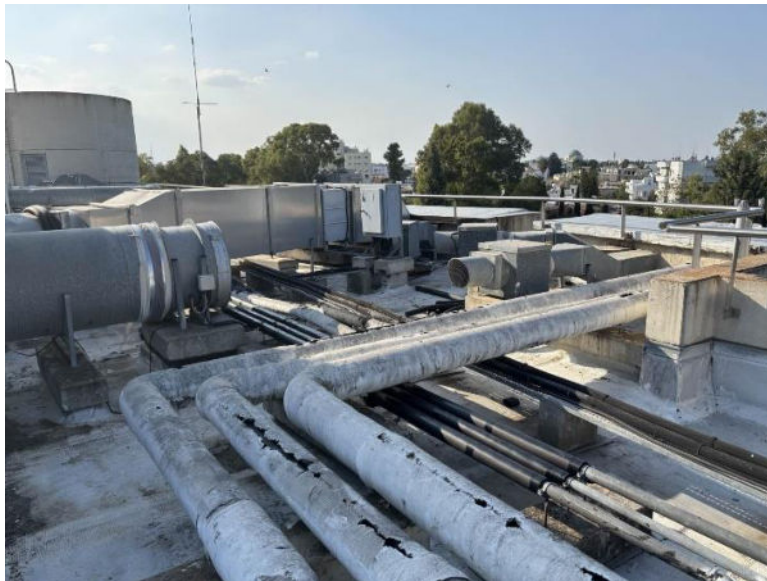
*Figure 18: Piping wear and damages*

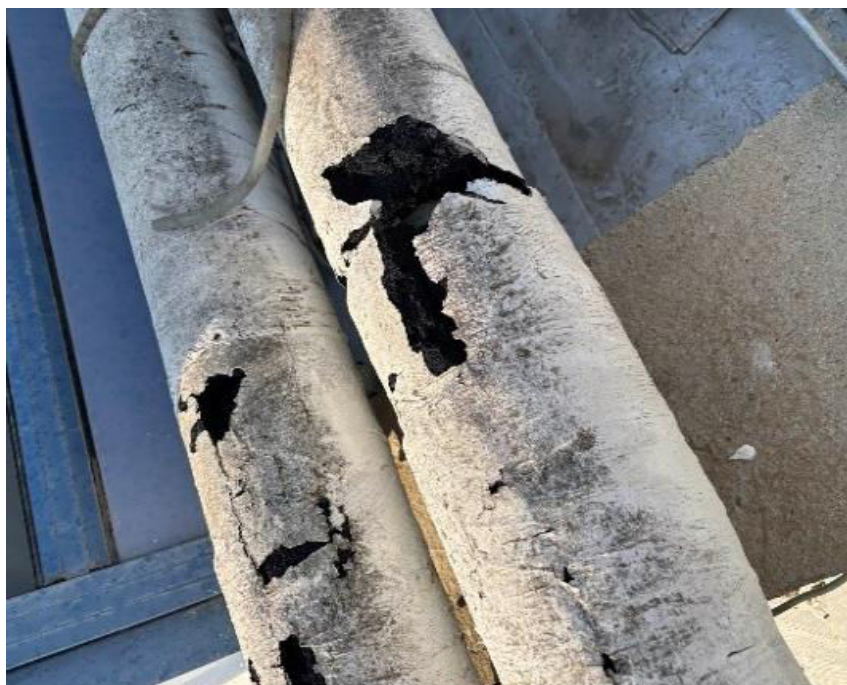
*Figure 19: Piping wear and damages*
